NONDESTRUCTIVE EVALUATION OF GRAPHITE/EPOXY COMPOSITE DAMAGE

S. W. Schramm, I. M. Daniel, and W. G. Hamilton
IIT Research Institute
Chicago, Illinois 60616

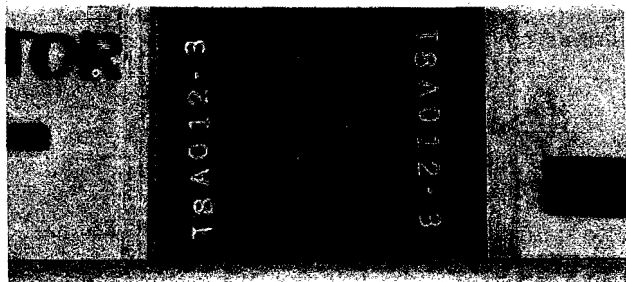
Fig. 1

Test Specimen with Initial Flaw (Hole)
Before Fatigue Loading

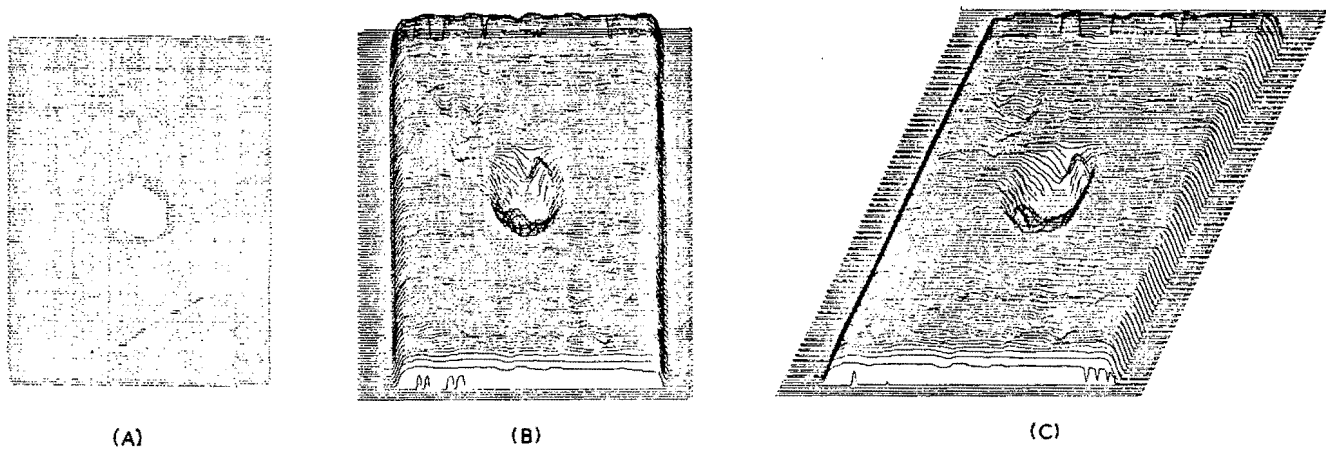
Fig. 4

The transducer is linked to an X-Y recorder via displacement transducers so that a hard copy of the data can be generated. Figure 4 shows the various types of scans which can be generated by the system at this time. Figure 4a is a C-scan representation of a [(0/±45/90)_s]₂ graphite/epoxy specimen with an initial flaw in the form of a circular hole. In this mode an alarm circuit with two limits is used

Figure 4b is an analog scan of the same specimen. In this mode the gated peak voltage of the reflected pulse is recorded as a deflection of the pen normal to the scanning direction. The variations of this voltage are related to the presence of flaws.

Figure 4c is an offset angle analog scan of the same specimen. In this mode a component of the X-axis signal is fed into the Y-axis signal resulting in a perspective view of the specimen. Flaws now appear as troughs and gray tones on a uniformly displaced background.

Ultrasonic C-scans of $[(0/\pm 45/90)_s]_2$ Graphite/Epoxy Specimen with a Circular Hole
(a) Pen-Lift Scan, (b) Analog Scan (Normal), (c) Analog Scan (Perspective)
